# STRUCTURE RISK ASSESSMENT

## TEMPLE ROAD

Contract: **2014s0927**  
Client: **Dun Laoghaire Rathdown County Council**

Asset Number: **14**  
Asset Name: **TEMPLE ROAD**  
XY Location (ING): **321704 229290**

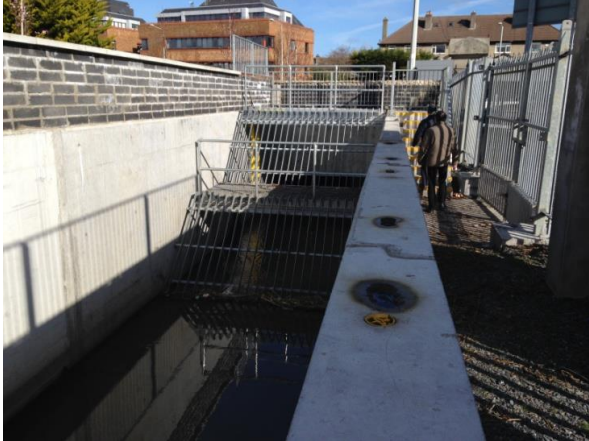
<b>Appropriateness of Screen</b>	The newly installed trash screen allows for access and maintenance but the likelihood for blockage remains unacceptably high due to the close bar spacing capturing large amounts of smaller vegetation debris, which could safely pass through the structure without issue. It is recommended to adjust the bar spacing to allow for a wider interval. Should blockage remain an issue then it may be necessary to implement CCTV and explore the option of an upstream pre-screen to reduce blockage risk.
<b>Likelihood of Screen Blockage</b>	The screen is subject to a history of partial obstructions related to the supply of vegetation from an upstream park. Man made sources of blockage are limited due to high local walls and railings. The likelihood of blockage remains high and a high level of maintenance along with a pre-screen may be advisable to catch additional debris. In its present configuration, the likelihood of blockage remains very high.

Upstream Face

RECOMMENDATIONS: WIDEN BAR SPACING, CONSIDER INSTALLING A PRE-SCREEN IF BAR SPACING NOT EFFECTIVE AND IMPLEMENT MONITORING/MAINTENANCE/EMERGENCY STRATEGY

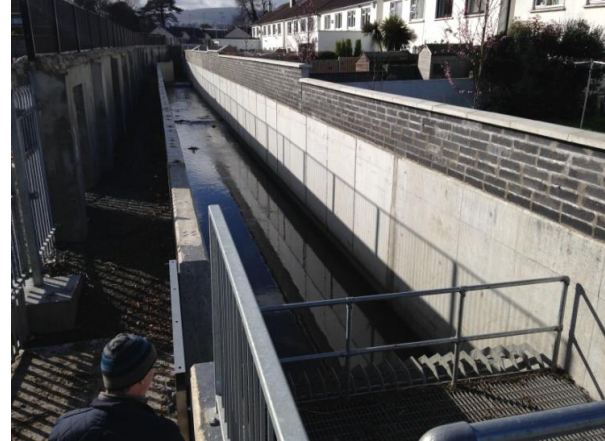
Upstream View

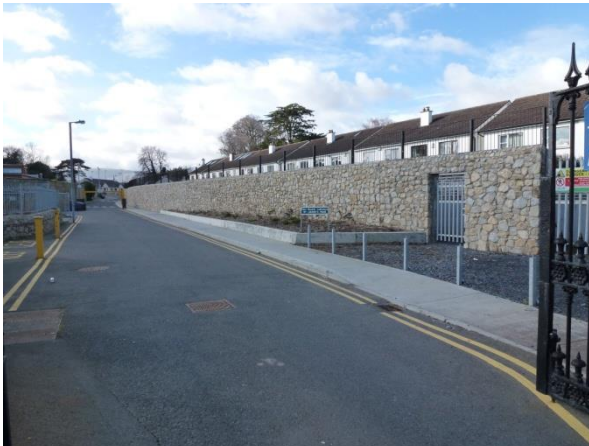
Upstream View of Masonry Wall

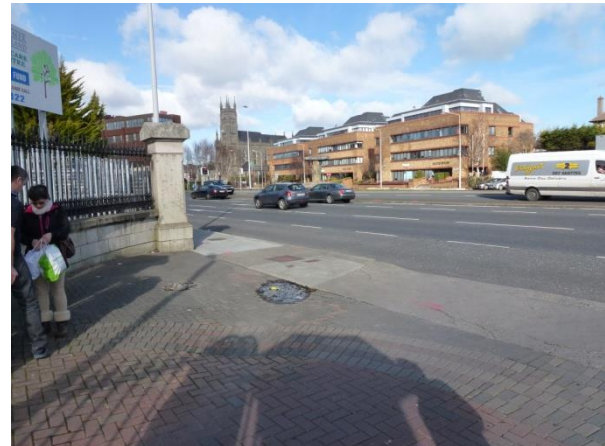
Downstream View across Temple Road

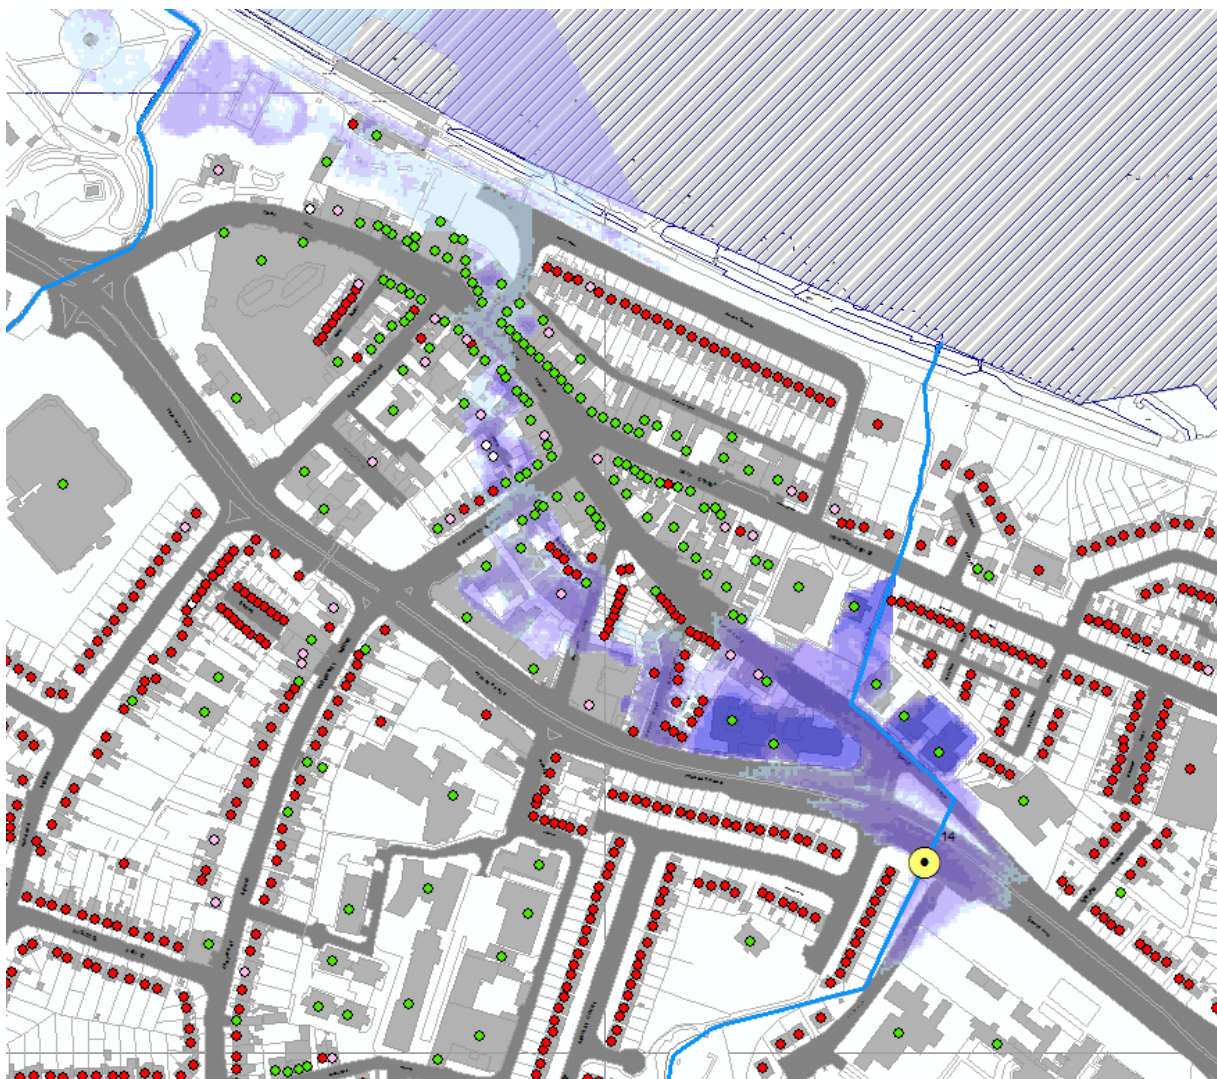
## BLOCKAGE IMPACT ANALYSIS: 1% AEP (100 year) flow:

Culvert blockage at this location would result in surcharging and significant overland flows resulting in impacts to 38 local properties and approximately 300m of the N31. Properties potentially impacted by the 1% AEP (100 year return period) flood are detailed in the table below and is presented visually in the mapping at the end of this report.

Should culvert blockage occur the overland flow route impacts 300m of the N31 and 38 properties as surcharging flows make their way over the N31 towards and flowing in the north westerly direction overland towards the Irish Sea. The Dart line is also potentially impacted. Culvert design is considered to be appropriate in terms of sizing and configuration; blockage likelihood can be managed by monitoring and maintenance measures.
